IMPLEMENTING A COMPUTER VISION SYSTEM FOR CORN KERNEL DAMAGE EVALUATION

L. W. Steenhoek, M. K. Misra, C. R. Hurburgh Jr., C. J. Bern

ABSTRACT. A computer vision system was developed for evaluation of the total damage factor used in corn grading. Major categories of corn damage in the Midwestern U.S. grain market were blue-eye mold damage and germ damage. Seven hundred twenty kernels were obtained from officially sampled Federal Grain Inspection Service (FGIS) corn samples and classified by inspectors on the Board of Appeals and Review. Inspectors classified these kernels into blue-eye mold, germ-damaged, and sound kernels at an 88% agreement rate. A color vision system and lighting chamber were developed to capture replicate images from each sample kernel. Images were segmented via input of red, green, and blue (RGB) values into a neural network trained to recognize color patterns of blue-eye mold, germ damage, sound germ, shadow in sound germ, hard starch, and soft starch. Morphological features (area and number of occurrences) from each of these color group areas were input to a genetic-based probabilistic neural network for computer vision image classification of kernels into

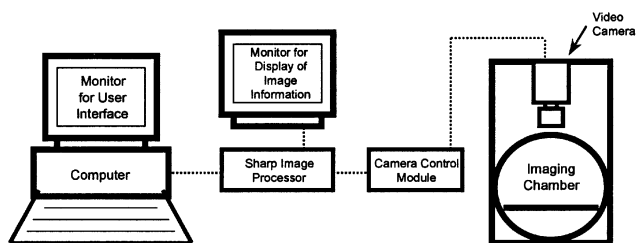
An image processing system developed by Sharp Digital Information Products (Sharp Digital Information Products, 1996) was used in this study. Components, as illustrated in figure 1, are (1) a Pentium computer with Windows 95 operating system, (2) a frame processor board to capture, process, and display images, (3) a color camera, (4) an image acquisition chamber, (5) a monitor to display of images, and (6) a user interface monitor.

Figure 1. This diagram shows an image processing system.

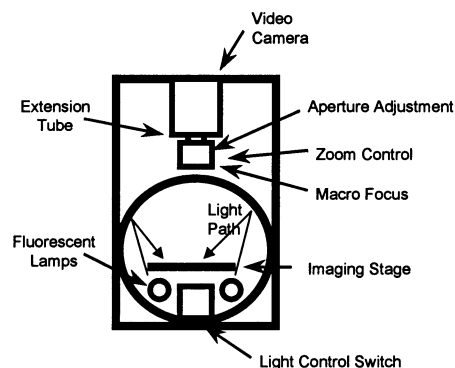
Lamps were attached to the bottom of a 6-mm thick clear polycarbonate plastic imaging stage and placed inside a white polycarbonate light diffusion tube of 240-mm diameter, 760-mm length, and 2.4-mm wall thickness as shown in figure 2. Reflective opaque black paper placed on the bottom side of the imaging stage and over the lamps blocked direct light and provided good contrast for background segmentation of the corn kernel images.

Figure 2. The diffuse lighting chamber with fluorescent lighting.

due to (1) the availability of rare earth-activated phosphor lamps for enhanced color rendition and visual clarity, (2) long lamp life compared with incandescent (20,000 vs. 2,000 h), (3) cooler operating temperature due to higher operating efficiency, (4) less generation of infrared wavelengths that tend to bias video camera sensors, and (5) availability of physical lamp size and power level that matched dimensions of the lighting chamber.

Two Philips brand Ultralume U-tube lamps (FB40/30U/6 and FB40/35U/6) were combined to approximate the camera's factory calibrated light temperature. These specialty lamps were found to perform well in comparison with halogen and other types of lighting investigated. A high frequency (>20 kHz) ballast was used to eliminate lamp flicker inherent in a 60-Hz AC circuit.

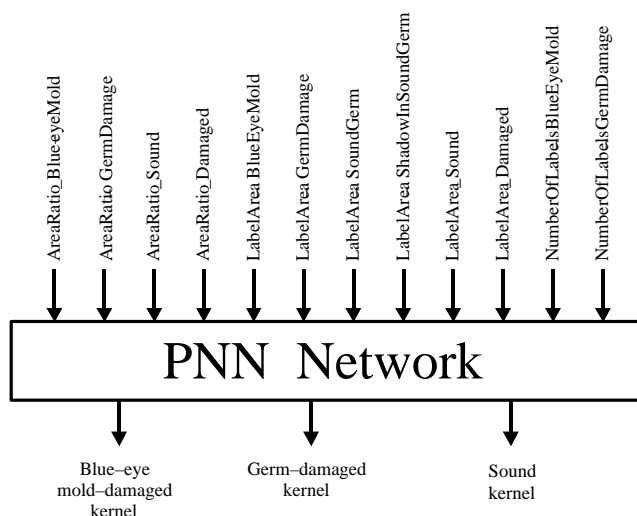
The probabilistic neural network (PNN) architecture implemented is illustrated in figure 3. The 12 input features were mapped to outputs representing kernel categories of sound, blue-eye mold, and germ damage. For each network output, a value between 0 and 1 represented the network's predicted probability for that category. A winner-take-all decision rule (largest output wins) gave the expected classification. Ward Systems Group (1997) NeuroShell

Figure 3. Kernel classification network architecture.

EasyClassifier software was used to implement a genetic variant of the PNN that applied an independent smoothing factor according to the relative importance of each input variable. The algorithm in NeuroShell EasyClassifier software required only a training and validation set. Of the 2,160 original corn kernel images, 252 (84 nonconcurrency kernels \times 3 replicate images) were excluded from network modeling due to inspector nonconcurrency. Segmented features from 477 images were used to train the network. The remaining 1,431 images were used to validate the network.
